Voice of America Mall Target Project: A Steel Push Pier Underpinning Case Study

by Howard Perko, Bill Bonekemper, Dave Jacob and Brian Dwyer
Magnum Piering, Inc., West Chester, Ohio

March 18, 2003

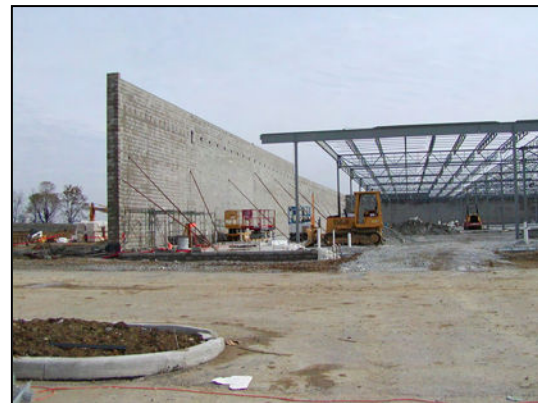
The first wall that the owner, the construction manager, and Dwyer's Dave Jacob visited was the north wall – the wall with the most severe problem. A considerable crack in the interior concrete slab was immediately apparent, and it measured approximately 1/2" to 5/8" wide at its worst point. The crack ran adjacent to the wall for approximately 200 feet and ranged in distance from 3 to 4 feet from the wall's base. The two men quickly pointed to some hand written measurements marked at eye level on the wall about every 20 feet. As they explained to Dave, these markings represented the distance the north wall had rolled outward (to the north) at the top of its 27 foot height as measured by the steel contractor on October 10th. The measurements ranged from a minimum of 1/8", close to both the west and east corners of the wall, to a maximum of 2-3/4", near the center of the wall's 310-foot total length.

Fig. 1 North Wall of Target Store Under Construction

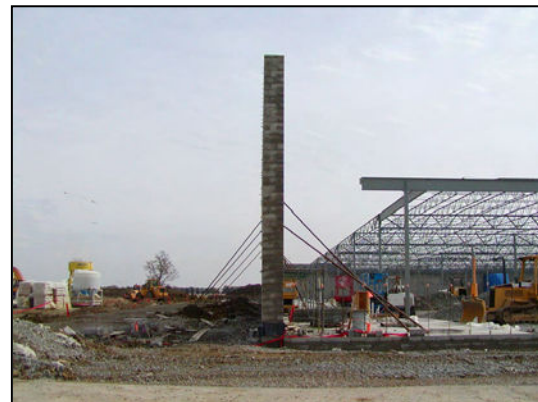
Fig. 2 North Wall of Target Store Showing Lateral Bracing

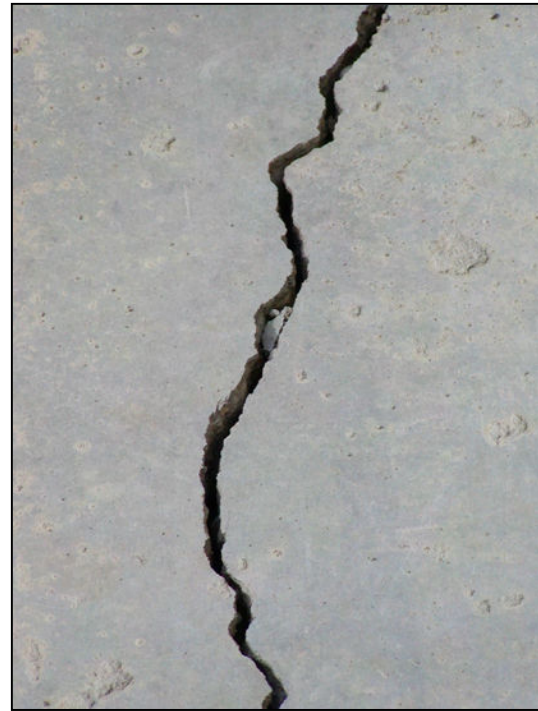
Fig. 4 Close-up View of Example Floor Slab Crack

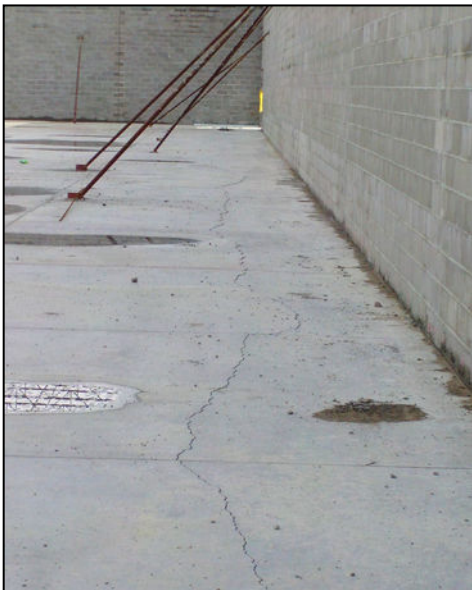
When the three men finished discussing the conditions at the north wall, they quickly went to examine the similar conditions at the structure's south wall. Although the settlement and subsequent outward roll of the south wall was not as severe as with the north wall, the top of the south wall had rolled outward (south) 1-7/8" inches near the center of the wall's 260 foot total length, as recorded by the steel contractor. The concrete slab also had a crack similar to the crack at the base of the north wall. The slab crack is shown in Figs. 3 and 4. A similar foundation design change had been made on this side of the building due to the close proximity of the property boundary. The foundation failure of the south wall was again attributed to the eccentric loading on the spread footing for the first approximately 200 feet of the wall measuring west to east. A photograph of one of the cracks in the CMU block wall is shown in Fig. 5.

Fig. 3 Example Floor Slab Crack Adjacent to South Wall

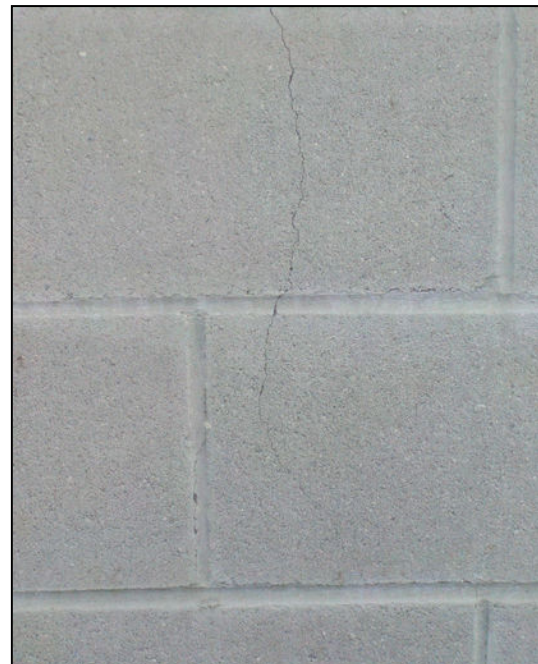
Fig. 5 Example Vertical Crack in South Wall of Target Store

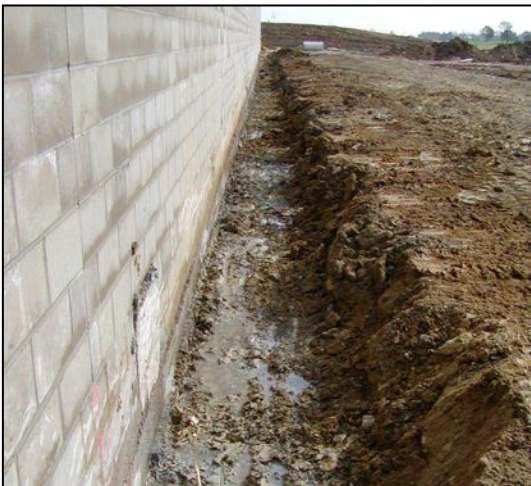
Due to the close proximity of the adjacent property line, the design was changed and instead the first approximately 250 feet of the wall's footing was shifted inward and constructed flush with the exterior alignment of the CMU block wall. This change in the foundation design, in conjunction with heavy amounts of rain at the site for several days, were deemed, by Elford's structural engineers and the contracted geotechnical firm for the project, to be the sources of the failure.

Adjacent property lines to the south and north walls were extremely close. In fact, the store width was only 8 inches smaller than the lot width. This condition necessitated that the foundation had to be virtually flush with the block wall as shown in Fig. 8.

Fig. 8 As-Built Spread Footing Shown Nearly Flush with Exterior Wall

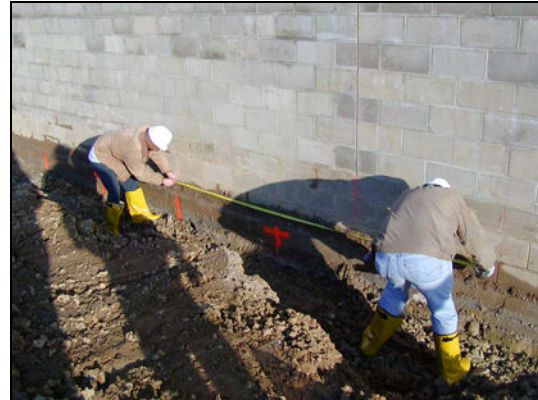
Fig. 9 Marking Bracket Positions Along Foundation Walls

Next, bracket positions were marked along the wall, as shown in Fig. 9. Each Magnum Piering bracket was secured using $\frac{1}{2}$ inch diameter by $5\frac{1}{2}$ inch long, expansion bolts extending into the side of the footing. Normally, the footing is chipped flush with the foundation wall prior to bracket installation in order to minimize

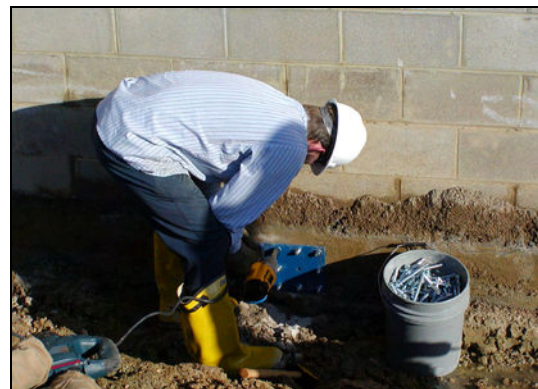
Fig. 10 Bracket Installation

rotational eccentricities. This step could be skipped, since the footing was already flush with the wall above. Bracket installation is shown in Fig. 10.

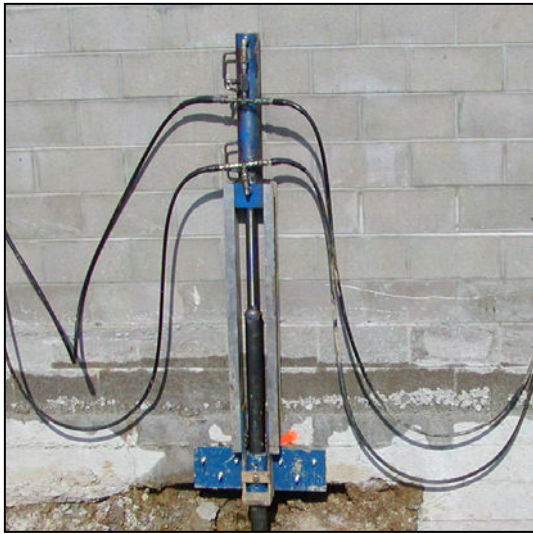
Fig. 11 Pier Installation

Next, the ram assembly is attached to the bracket and the installation of 30 inch sections of 3 inch O.D. high strength steel pier shaft is conducted, as shown in Fig. 11.

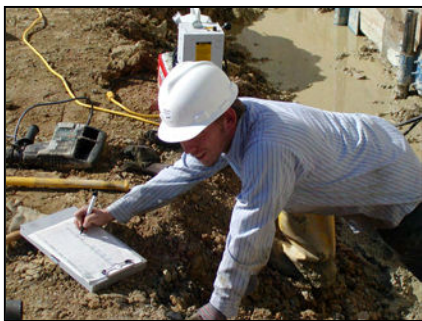
Fig. 12 Logging Pier Depth and Hydraulic Pressure

Hydraulic pressure during pier installation is recorded at various depths, as shown in Fig. 12. A log of these readings is prepared for each pier location. Pier installation is halted once the hydraulic pressure corresponding to the design ultimate capacity of the pier is reached. At that point, the load is maintained on the pier and movement is monitored over a period of time until the pier movement decreases to less than 1/16th inch per ½ hour. This process constitutes a full-scale load test at each pier location.

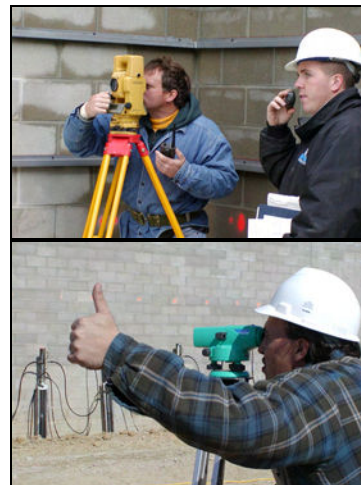
Fig. 13 Monitoring Wall Movement During Lifting Phase

Survey stations were established inside and outside the building in order to monitor movement, as shown in Fig. 13.

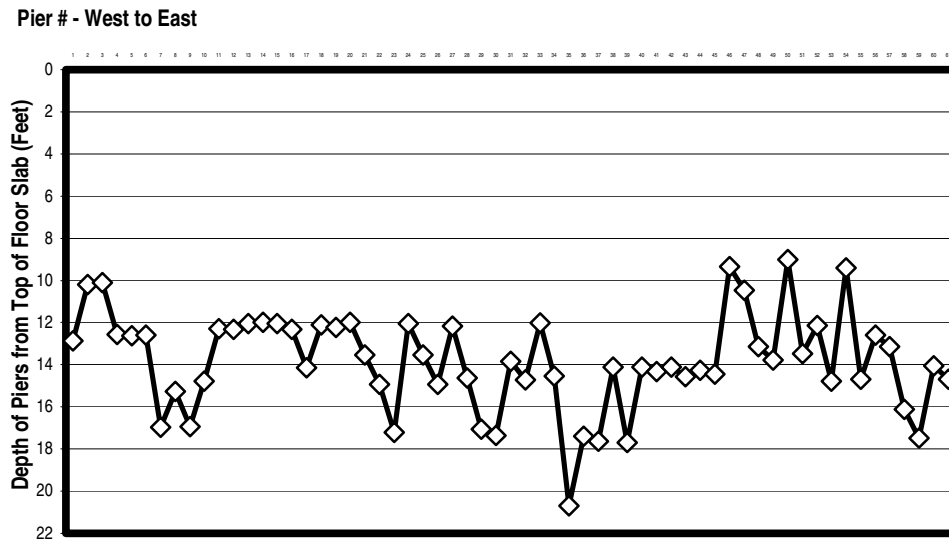
As can be seen in the figures, the final depth of the piers along the North wall varied from 10 to 20 feet below the top of slab and along the South wall from 15 to 19 feet. In either case, a discernable profile is evident. The reason for larger variation in pier depth on the North side of the site is unknown. However, the depth of the piers was generally consistent with the depth and variability of bedrock described in the geotechnical engineer's report for the project site. It was concluded that all piers are likely supported on or within the bedrock.

Fig. 14 Final Pier Depths Along North Wall

At the Target Store, the design ultimate capacity of each pier was 35 kips. In order to add to the factor of safety and ensure proper pier installation, Dwyer personnel installed each pier to the maximum load that could safely be applied to the structure (40 kips), which corresponds to a hydraulic ram pressure of approximately 5,000 psi. The final depth of the piers along the North and South walls of the building are shown in Figs. 14 and 15.

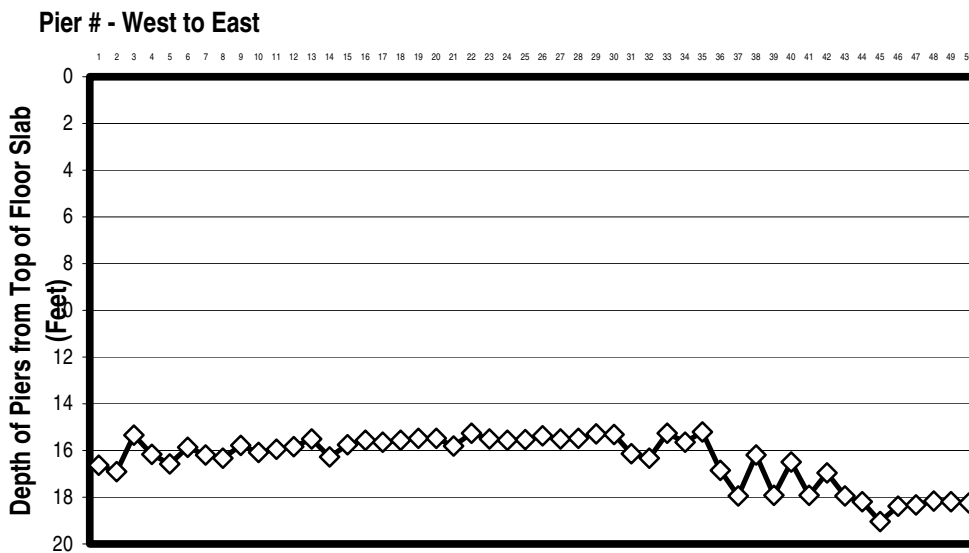
Fig. 15 Final Pier Depths Along South Wall

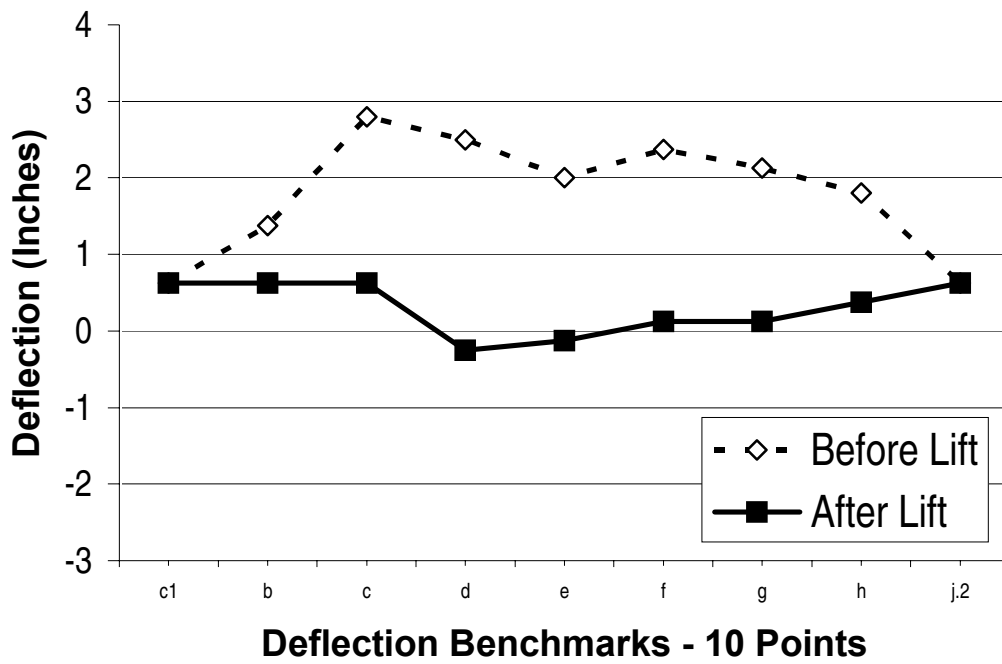
Fig. 16 Initial and Final North Wall Top Location

Both walls were successfully relocated. Initial and final top of wall locations with respect to plumb are shown in Figs. 16 and 17. The North and South walls were restored to within ½ inch of plumb, except for the Eastern portion of the South wall. The reason for this discrepancy is that the wall was not constructed perfectly straight. It was identified during this phase that the South wall had started to settle during masonry construction, and the block mason had to adjust the course of the wall. Afterward, the wall continued to move and eventually ended in the position where Dwyer was called to the site. The wall could not be improved beyond that shown unless it was reconstructed. It was deemed that the lift was acceptable and the underpinning project was completed.

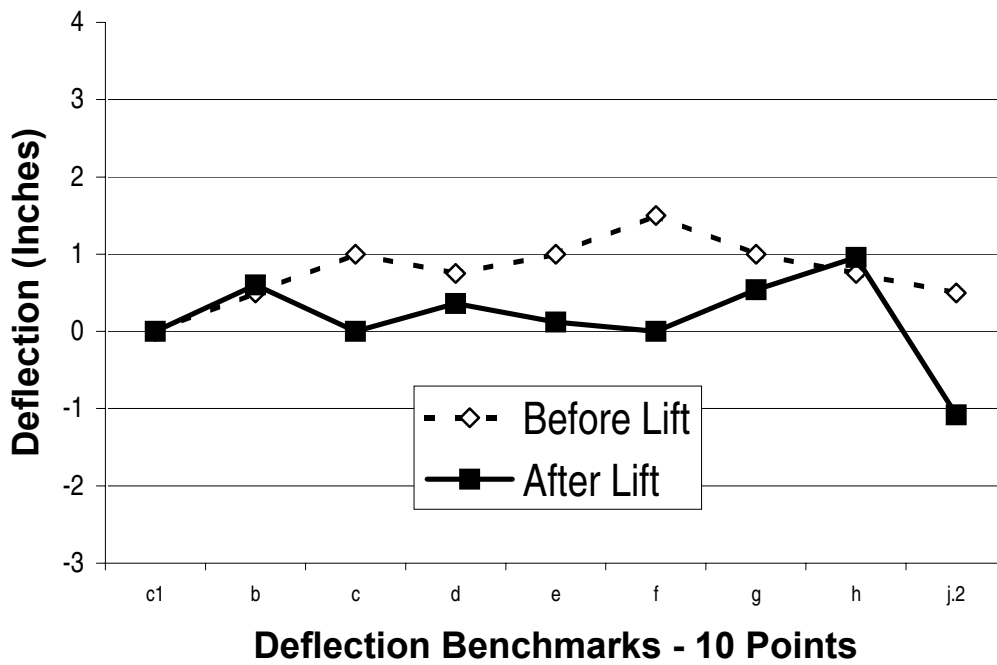
Fig. 17 Initial and Final South Wall Top Location
