Voice of America Mall Target Project: A Steel Push Pier Underpinning Case Study

by Howard Perko, Bill Bonekemper, Dave Jacob and Brian Dwyer
Magnum Piering, Inc., West Chester, Ohio

March 18, 2003

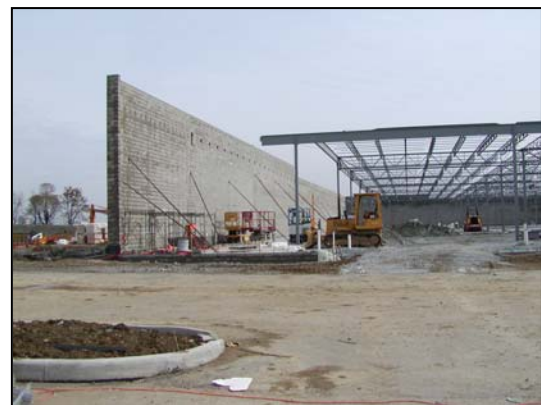
Fig. 1 North Wall of Target Store Under Construction

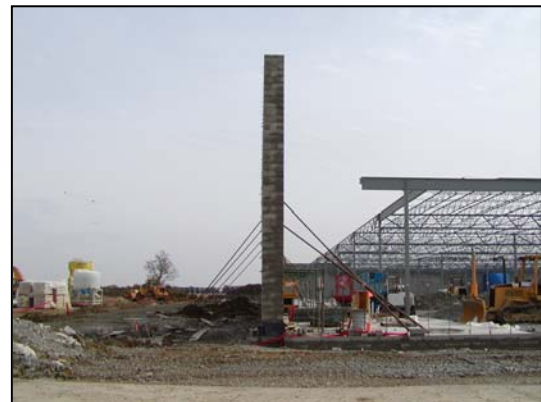
Fig. 2 North Wall of Target Store Showing Lateral Bracing

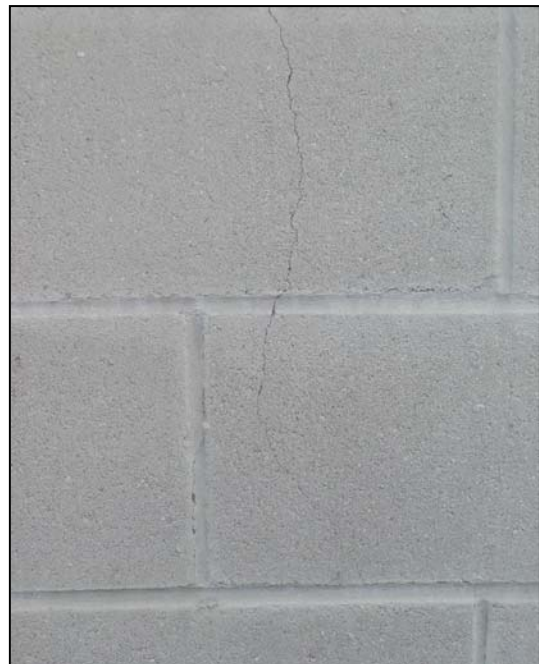
Fig. 5 Example Vertical Crack in South Wall of Target Store

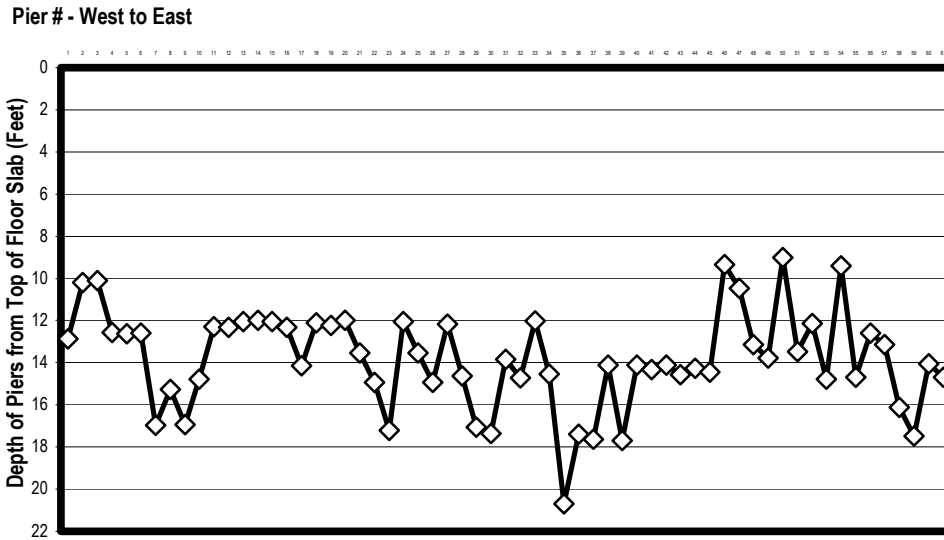
As can be seen in the figures, the final depth of the piers along the North wall varied from 10 to 20 feet below the top of slab and along the South wall from 15 to 19 feet. In either case, a discernable profile is evident. The reason for larger variation in pier depth on the North side of the site is unknown. However, the depth of the piers was generally consistent with the depth and variability of bedrock described in the geotechnical engineer's report for the project site. It was concluded that all piers are likely supported on or within the bedrock.

Fig. 14 Final Pier Depths Along North Wall

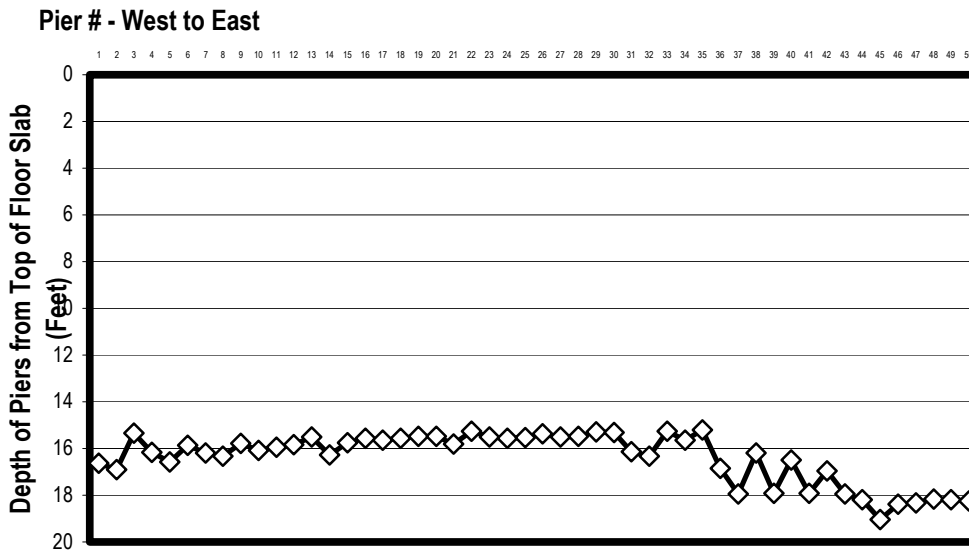
Fig. 15 Final Pier Depths Along South Wall

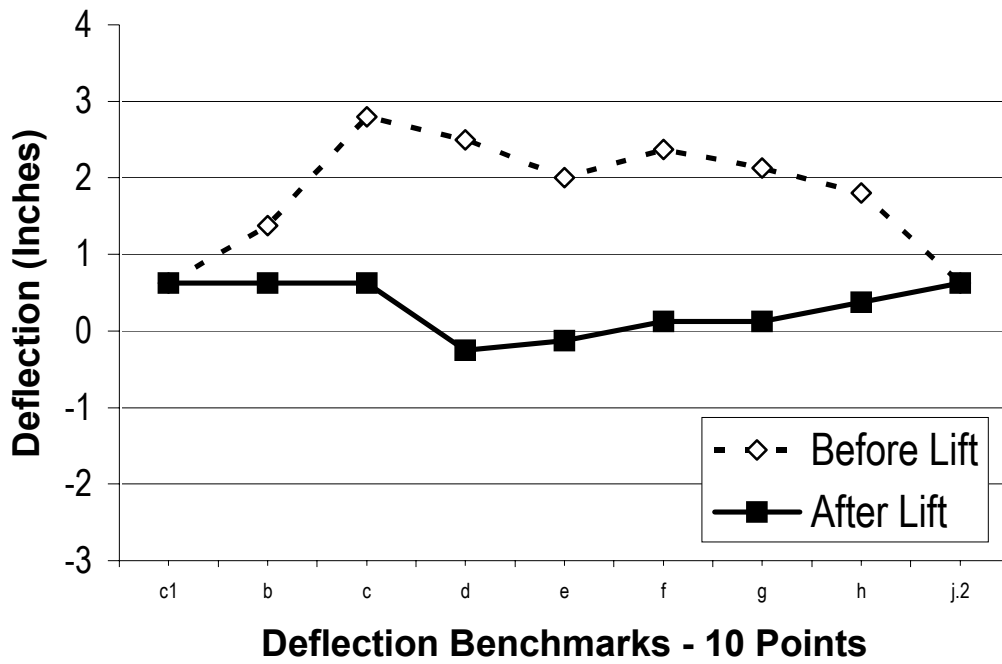
Fig. 16 Initial and Final North Wall Top Location

Both walls were successfully relocated. Initial and final top of wall locations with respect to plumb are shown in Figs. 16 and 17. The North and South walls were restored to within ½ inch of plumb, except for the Eastern portion of the South wall. The reason for this discrepancy is that the wall was not constructed perfectly straight. It was identified during this phase that the South wall had started to settle during masonry construction, and the block mason had to adjust the course of the wall. Afterward, the wall continued to move and eventually ended in the position where Dwyer was called to the site. The wall could not be improved beyond that shown unless it was reconstructed. It was deemed that the lift was acceptable and the underpinning project was completed.

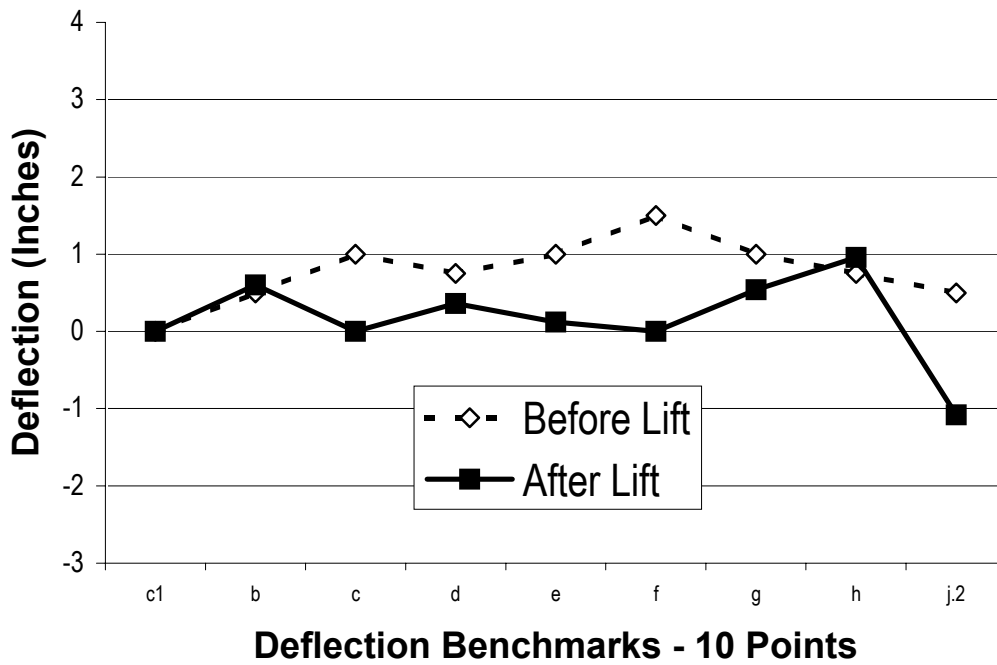
Fig. 17 Initial and Final South Wall Top Location
