Sweden Case Study

Deep FoamjectionTM

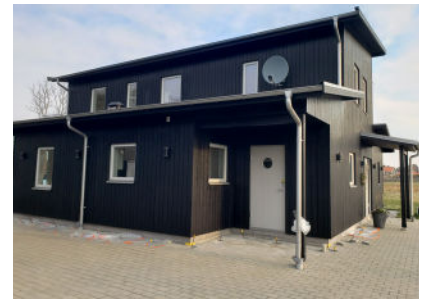
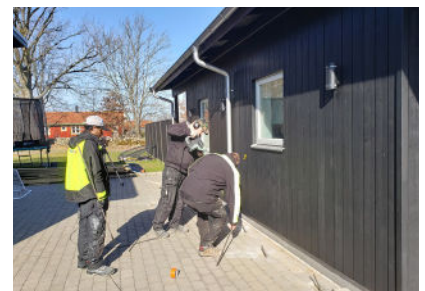
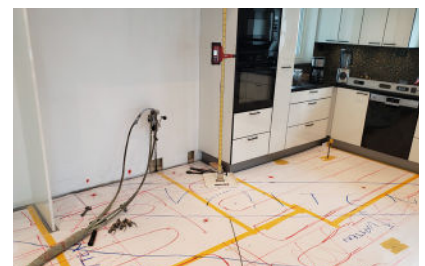
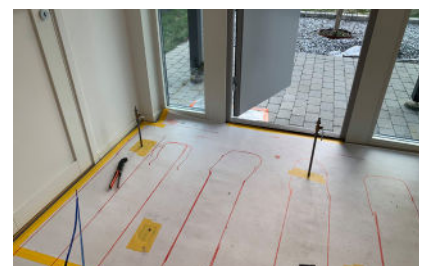
1. Per Sweden's building code, there is 2.5 ft of insulation board directly under the homes flooring. Therefore the injection would need to start that much deeper to address the failing soils.
2. A waterproof membrane was directly under the utility room that could not be punctured, therefore no drilling could be done in the utility room. This room would have to be lifted and stabilized from outside the home and the perimeter of the room (inside the kitchen)
3. The entire home had radiant in floor heating, the local fire department used infrared technology to detect where the heating lines were located. These were indicated with red lines on flooring paper put down throughout the entire home. The blue lines indicated the boiler heat for the home. (Shown in photos to the right) Because of this there were large areas of the home that could not be drilled down into.

The contractor started outside on the most settled corner of the home. All outside pipes were angled to get material underneath the slab and foam board insulation. They installed pipe 6-9 feet, 4 feet below the insulation board. A soil boring report indicated what depth the weak soils were at. A plural component material was injected into the ground. The material expanded into foam that added strength to the soil as it expanded. As more foam was installed pressure was built to lift the slab.

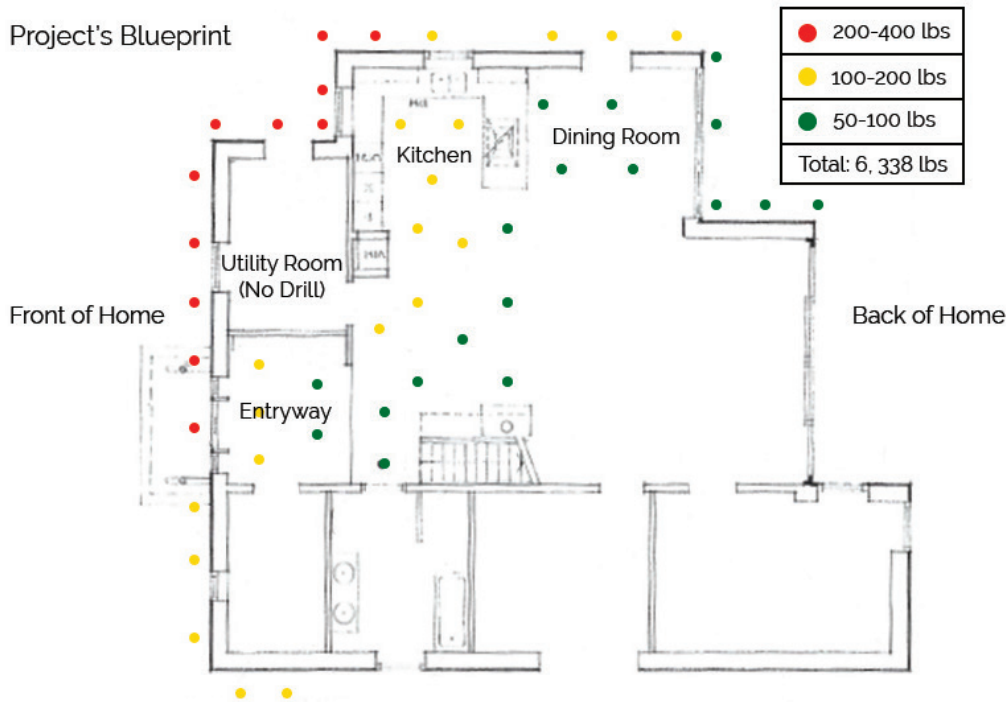
This map identifies that areas where material was injected to stabilize and lift the slab. The areas in red received the most foam where the slab was raised up to 3 ½ inches. The yellow and green areas supported the lift and stabilized the slab.
