Case Study

Kewaunee Seawall Repair

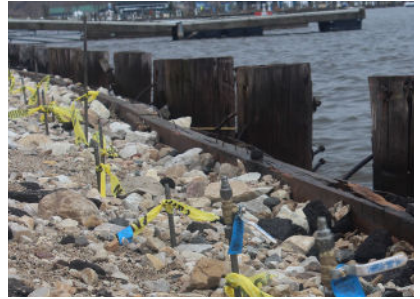
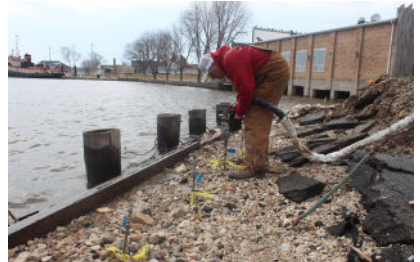
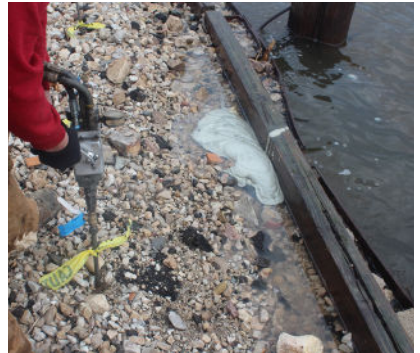
Foam setting up in water.
No Chemicals leaching into the water.

RaiseRite Concrete Lifting used the Deep Foamjection™ process to stabilize the soil to support the barrier and prevent further erosion and loss of soils. Deep Foamjection™ is the process of injecting foam to specified depths to increase the load bearing capacity of the soils. The foam used for this project was crucial because a truly hydro-insensitive foam was needed. HMI Hydrofoam was specifically designed for jobs where water or moisture is present. This 4 lb. per cubic foot foam was designed to set up in the presence of water and to maintain dimensional stability in wet environments. (As shown in the picture to the right- no chemicals are leaching into the water, and the foam is setting up perfectly). The project was completed in 4 days and 4,175 lbs. of HMI 402 HydroFoam was injected. The customer could then immediately continue repairs to the parking lot.
