Voice of America Mall Target Project: A Steel Push Pier Underpinning Case Study

by Howard Perko, Bill Bonekemper, Dave Jacob and Brian Dwyer
Magnum Piering, Inc., West Chester, Ohio

March 18, 2003

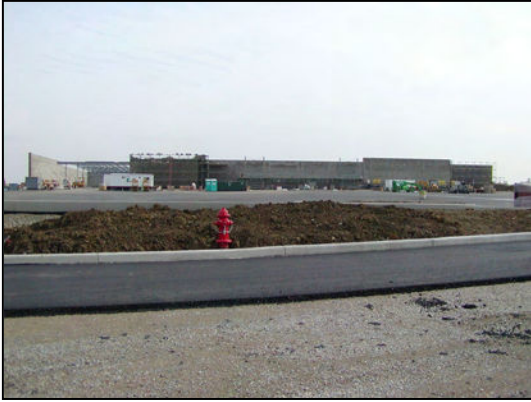
Fig. 6 Distant View of Target Store Site

A view of the Target Store from a distance is shown in Fig. 6. A view of the inside of the store at the time of repair is shown in Fig. 7. This figure reveals that the store consists of a combination of masonry and steel construction. The rectangular store footprint encompassed approximately 120,000 sq. feet, and measured roughly 310 ft x 400 ft.
