Sweden Case Study

Deep FoamjectionTM

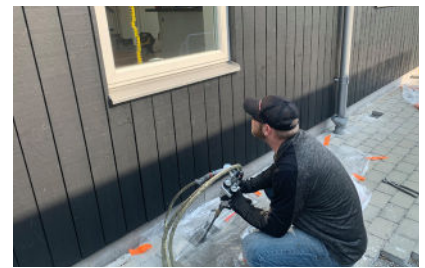
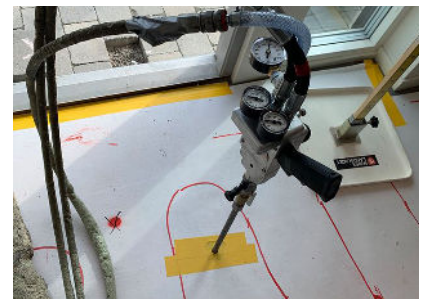
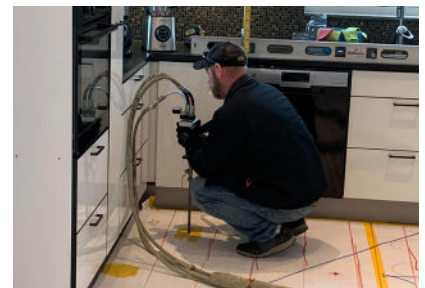
The team lifted in small increments to avoid damage. After they achieved 1 inch lifts, they would move and re-laser the entire home to monitor how much lift was still needed in each area. Approximately 100-150 lbs of foam was pumped at each injection point. Once the outside of the home was stabilized and lifted, they moved inside to finish the injections and stabilize the remainder of the slab.
