Case Study-Grain Bin

Deep Foamjection™ Stabilization and Raising Project

Unstable soils underneath a settled grain bin located in Cedar, Kansas.

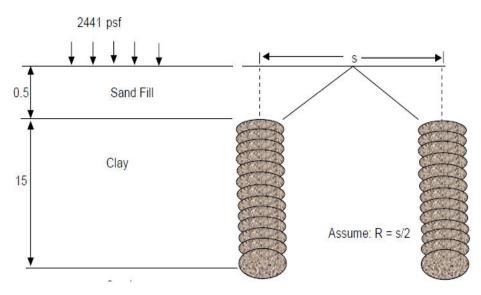
Previously installed geopiers had been installed at a depth of 15 feet. In conjunction with the weak subgrade, there was not enough strength to support the full weight of the filled grain bin, Half of the slab settled by 6 inches.

The full repair would require to first stabilize the subgrade, then attempt to lift the settled slab up to 6 inches. Alternative repair methods were bid exceeding \$1M with months of demolition and construction. With fall harvest approaching this repair was time sensitive.

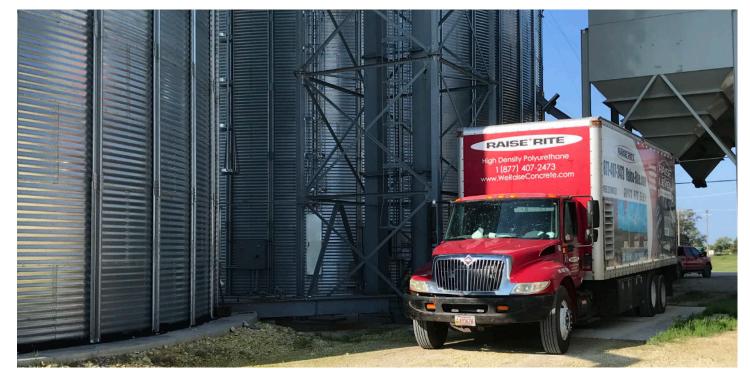
A four foot grid pattern of 106 points were used to install Hydrofoam 402 at a depth of 12-15 feet to stabilize the soil. Each injection point accepted 15-75 pounds of material as noted in the color-coded chart below. Using an HMI EliteONE injection gun, a total amount of 4,500 pounds of HF402 foam was incrementally installed into the soil to stabilize the subgrade. HF402 was chosen for stabilization due to the potential water present, strength and the ideal reaction profile for Deep Foamjection™.

60-75 LBS35-55 LBS15-30 LBS
