Case Study

Two Rivers Seawall Repair

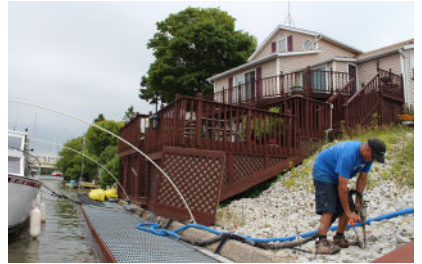
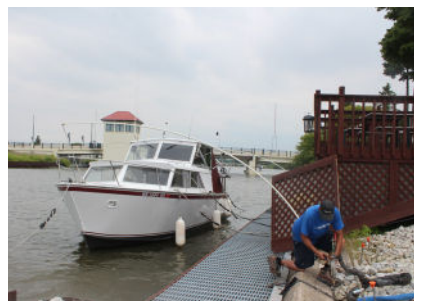
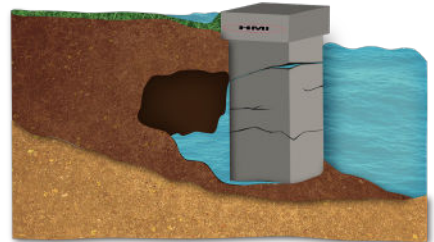
BEFORE

The seawall was constructed with wooden sheeting. With the lake levels down for a few years, this wood dried out and when the levels returned had rotted. This allowed the material behind the wall to erode. As this material eroded, the grade that went up to the house which supported the deck, began to sag.

RaiseRite Concrete Lifting (HMI's Contracting Division), used the Deep Foamjection™ process to stabilize the soil to support the deck and prevent further erosion and loss of soils. Deep Foamjection™ is the process of injecting foam to specified depths to increase the load bearing capacity of the soils. For this project RaiseRite installed 16 injection points approximately 5-10 feet under the ground. The foam used for this project was crucial because a truly hydro-insensitive foam was needed. HMI Hydrofoam was specifically designed for jobs where water or moisture is present. This 4 lb. per cubic foot foam was designed to set up in the presence of water and to maintain dimensional stability in wet environments. This job was quoted at \$10,000, saving the customer \$180,000. This process took the RaiseRite team one day to complete (8 hours) compared to 3 months it would have taken to install a new metal sheet-piling seawall.
